## **SERVICE BULLETIN**

- TO:** Owner/Operators of Pacific Scientific Company Restraint Systems using Buckle Assembly Part Numbers 1111430-XX and 1111475-XX.
- SUBJECT:** Information regarding the potential failure of the Guarded Rotary Buckle plastic handle.
- PURPOSE:** This Service Bulletin (SB) identifies suspect Buckle Assemblies and advises operators to return them to Pacific Scientific for exchange/replacement.

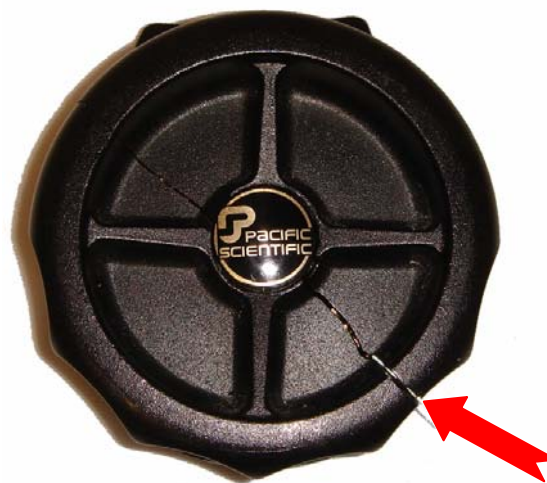
**Figure 1**

Pacific Scientific has recently received field reports of several instances of cracking on the guarded rotary buckle plastic handle. The buckle assemblies returned to and examined by Pacific Scientific had large, readily apparent cracks throughout the plastic buckle handle. Pacific Scientific is investigating the cause of these cracks.

**Part Number  
1111430-XX or 1111475-XX.**

Preliminary testing performed by Pacific Scientific on buckle assemblies with cracked plastic handles indicates that in some circumstances when a load is placed on the restraint system, the straps may not release as intended when the buckle is rotated. Pacific Scientific therefore recommends the mandatory, immediate replacement of the affected buckle assemblies.

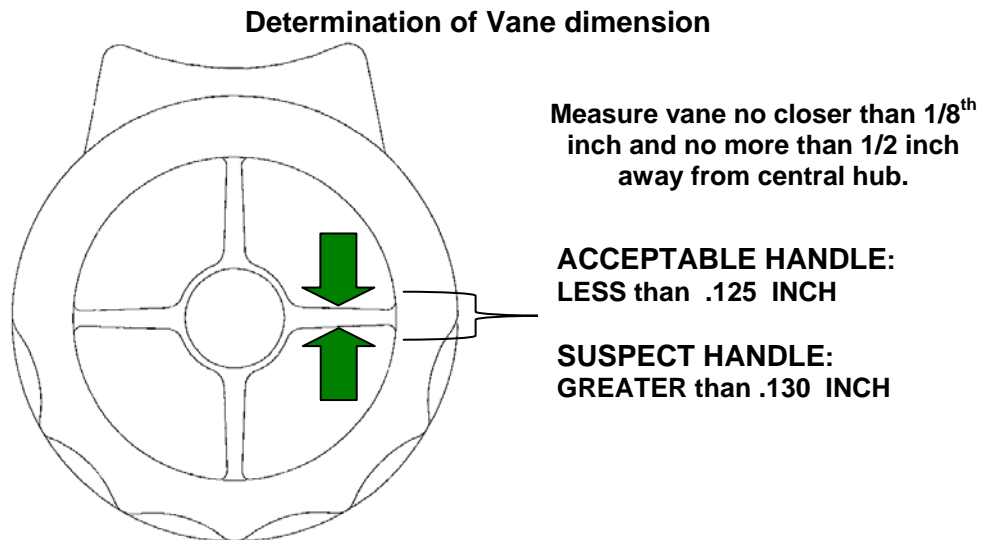
Figure 3

Suspect handles may also be identified by measuring the thickness of the handle vane. Measurement to determine suspect handles will be accomplished in accordance with Figure 3.

**ACCEPTABLE PARTS** will have a vane dimension **LESS** than **.125 INCH**

**SUSPECT PARTS** will have a vane dimension **GREATER** than **.130 INCH**

No special tools or fixtures are required. A simple shim to release the fixed position strap fitting from the buckle is required. (See Figure 3)
